MEDICAL DEVICE SAFETY ALERT

Medtronic Evolut™ PRO+ 34mm Transcatheter Aortic Valve

05 December 2022 | 10:23 SGT

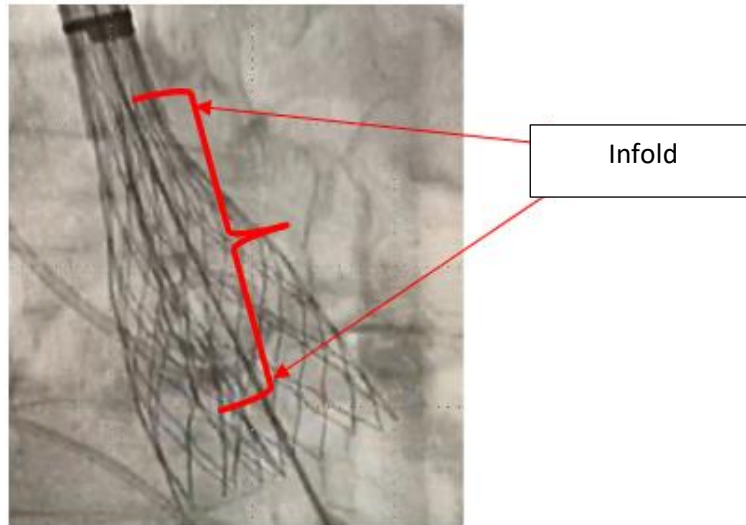
Infolding is a known phenomenon and occurs when the valve frame folds inward along a vertical line away from the valve inflow and appears as a seam in the frame or as overlapping frame cells on radiographic imaging (see figure 1). Infolding is different and distinct from valve under expansion and may be seen intraprocedurally at deployment or during recapturing of a valve.

Figure 1: Example of radiographic imaging depicting infolding.

Although the overall incidence of frame infolding is low in PRO+ TAVs, the PRO+ 34mm TAV has been associated with higher rates of infolding than other PRO+ sizes. From commercial launch (01 October 2019) to 31 August 2022, the PRO+ 34mm TAV infolding rate was 2.93%¹. Of this incidence rate, 0.32% resulted in serious adverse events, including two (2) deaths. Other serious adverse events may include unplanned surgery/intervention, such as surgical explant / valve replacement /aortic repair or implantation of a transcatheter valve within the initial valve (TAV in TAV), aortic regurgitation/insufficiency, paravalvular leak, hypotension, congestive heart failure, and aortic dissection.

- Infold detection steps are outlined in section 9.2.4. An observation of any inward fold or crease in the valve, extending from the inflow, identified as a dark line under fluoroscopic (cine mode) inspection, may indicate an infold. If identified, and if the patient's condition allows, do not proceed and do not release the valve.

- Recapture, remove and discard the entire system. The valve, catheter, loading system, loading tray, and saline all must be replaced with new sterile components.

- Pre-dilatation is strongly recommended prior to subsequent implantation attempts to minimize infold risk.
 - If initial pre-dilatation does not prevent infolding, reassess valve sizing in the presence of complex anatomies.
