Field Safety Notice / FSCA 003-22

Affected products displaying the issue:

Product Name	UDI-DI	Catalog No	Version	Serial Number
IH-500	07611969167623 03610522063697	001500 001500RECOND	All	All

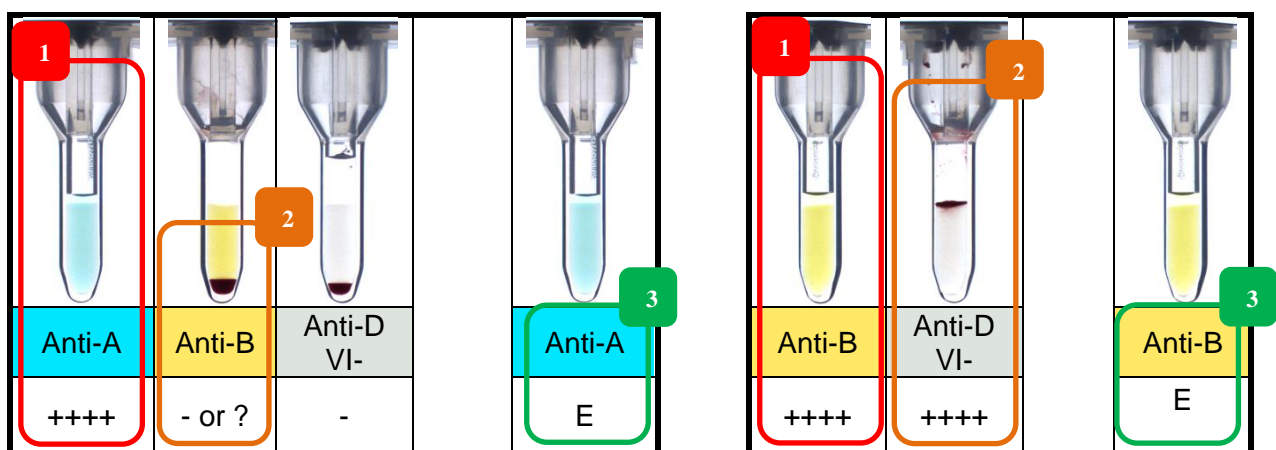
Figure 1: Unexpected and expected results for empty Anti-A (left) and Anti-B (right) wells

In case of absence of red blood cells (RBC) sample into the Anti-A well or Anti-B well, the reading algorithm of the IH-500 might not be able to properly detect the dispense failure and return the result as positive instead of Empty "E" as expected (See figure 1).

- (1) Unexpected behavior of IH-500: Non dispensed well returned positive “++++”
- (2) Non dispense in a well is generally followed by a double dispense in the subsequent well (negative results displayed as “?” or “-“, positive result displayed as expected)
- (3) Expected behavior of IH-500: Non dispensed well returned “E” invalidating the result

1. Ensure your preventive maintenance including needle replacement has been made according to our instructions.
2. As of now, verify all future results obtained on the Anti-A and Anti-B following one of the instructions below:

- a. *Deactivate the automatic reading function in the IH-Com (this will affect all tests results)*
- or
- b. *Contact your field application to determine the appropriate solution (e.g. configure a reflex test in IH-COM, send an automatic comment to your LIS)*

1. Invalidate the result
2. Repeat the test
3. If the issue persists, contact your customer technical support representative
