## URGENT Field Safety Notice

### Philips Azurion System R2.2.0, R2.2.1, R2.2.3, R2.2.5 and R2.2.6 Potential Loss of X-ray Functionality

16 March 2023

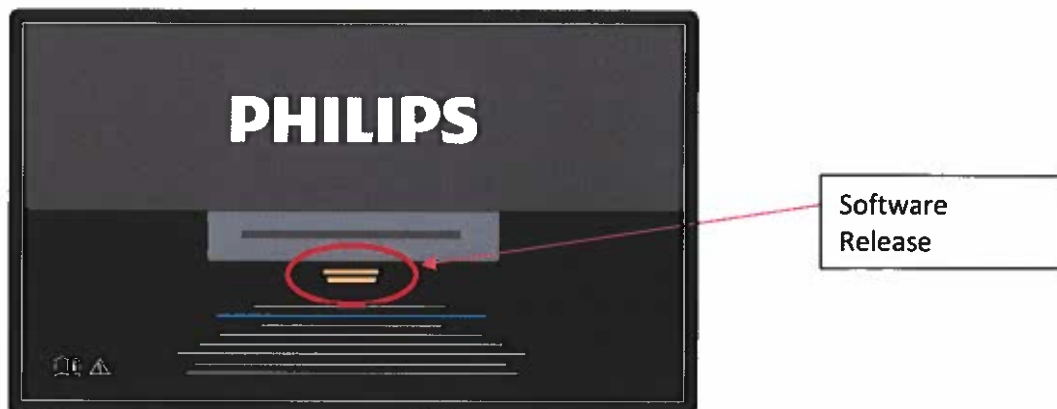
Figure 2: System start-up screen

The software version of the Philips Azurion system can be identified during start-up (Figure2).
