**URGENT Field Safety Notice**

Trilogy Evo O<sub>2</sub>, Trilogy Evo Universal, Trilogy EV300  
Accuracy of FiO<sub>2</sub> Delivery

01 MAR 2023

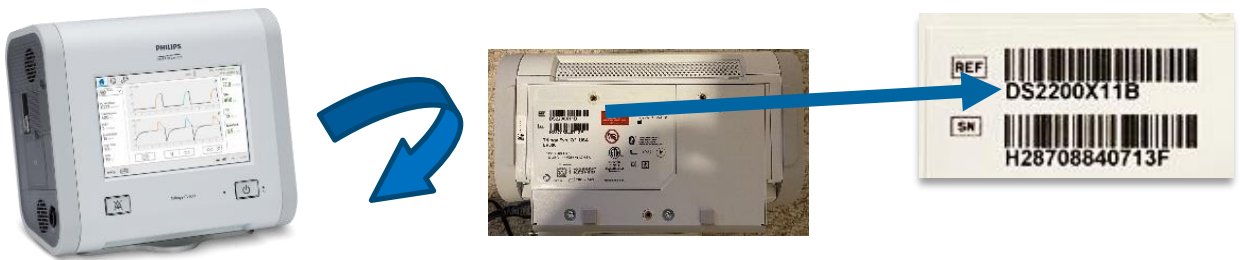
To identify the model, refer to the part number on the bottom of the device with the attached list of impacted part numbers:
