February 09, 2023

**URGENT FIELD SAFETY NOTICE
MEDICAL DEVICE CORRECTION**

Datascope Cardiosave Hybrid and Rescue Intra-Aortic Balloon Pumps (IABP)

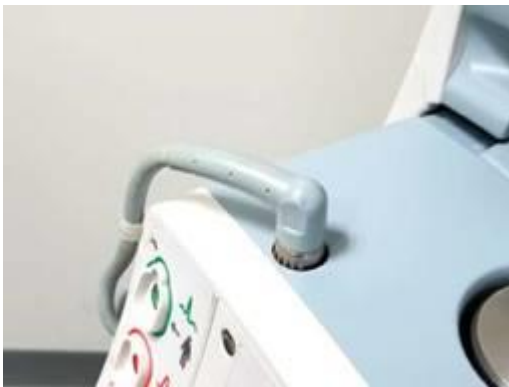
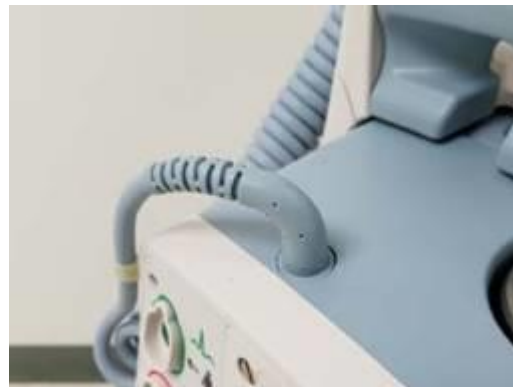
Figure 1: Representative picture of both the old and new Coiled Cable cord design.

An internal investigation of the complaints determined an unexpected shutdown may be due to damaged Coiled Cable Cords [part numbers 0012-00-1801 and 0012-00-1796] that provide bidirectional communication between the display head and base unit. Please refer to images below for reference.

Datascope/Getinge has received 25 reported complaints of damaged Coil cords resulting in unexpected shutdown over a 2 year period.

1. Prior to use of the Cardiosave IABP, inspect the coiled cable cord to ensure that there is no visible damage.

Datascope/Getinge has developed a hardware correction to address this issue. It is important to note that this issue is limited to units distributed prior to July 24, 2017. A Datascope/Getinge service representative will contact you to schedule the installation of the correction if your unit is affected as the correction kit becomes available. This work will be done at no cost to your facility.

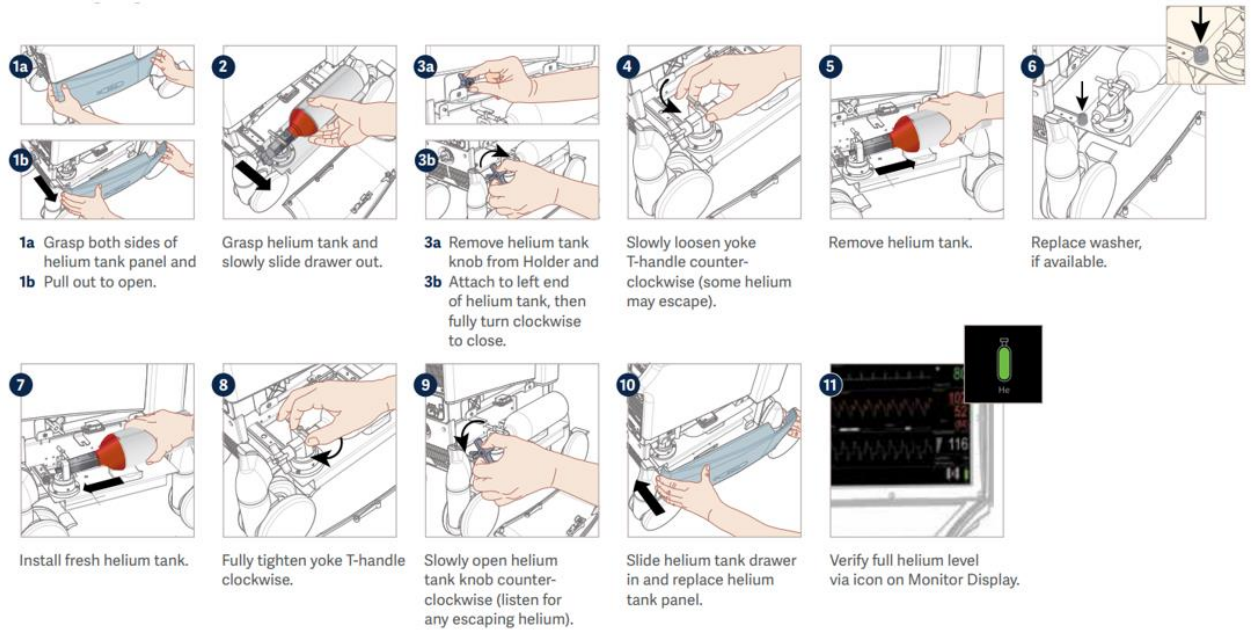
Figure 2: As pictured in **Cardiosave Hybrid and/or Rescue Operating Instructions**

There have been reported failures of the high pressure helium regulator which may cause a helium leak in the Cardiosave Hospital Cart. The high pressure helium regulator is located in the Cardiosave Hospital Cart and regulates the helium pressure of the external helium supply. In instance of helium regulator failure, a Pump Console's internal reservoir of helium will not be replenished when docked into an impacted Hospital Cart. This may result in an insufficient amount of helium within the internal reservoir. Please refer to images below for reference.

Datascope/Getinge has received 51 reported complaints of helium leak as a result of high pressure helium regulator failure over a 2 year period.

1. During Installation and Replacement of Helium Tank per the Cardiosave Operating Instructions, please ensure care is taken not to damage the helium tank or the helium tank yoke while inserting and/or removing the helium tank.
2. Please follow the instructions for use when changing the helium tank.

3. If user observes any visual damage on High Pressure Regulator, please contact your Datascope/Getinge service representative.

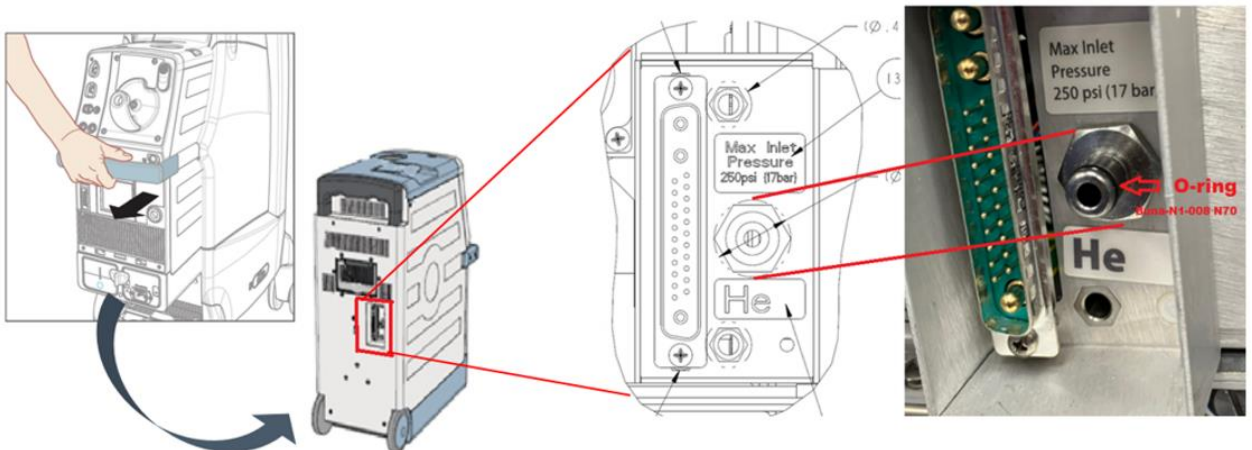
Figure 3: Drawings as pictured in **Cardiosave Hybrid and/or Rescue Operating Instructions**, along with a final picture of the O-ring as it appears on the unit.

There have been reports of damaged, worn, or torn O-rings on the Cardiosave Pump Console quick disconnect fitting resulting in helium tank leaks. The quick disconnect fitting is the point of connection that permits the refilling of the Pump Console's internal helium reservoir when the Pump Console is docked in the Hospital Cart. Please refer to images below for reference.

Datascope/Getinge has received 51 reported complaints of helium leak as a result of damaged, worn, or torn O-rings over a 2 year period.

1. If user observes any visual damage to the O-ring installed as part of the quick disconnect fitting, please contact your Datascope/Getinge service representative. If possible, remove the IABP from patient use until appropriate repairs can be made.

Datascope/Getinge is currently updating the annual Preventive Maintenance instruction to include replacement of the quick disconnect fitting O-ring.
