URGENT Field Safety Notice

Azurion and Allura Xper series

Potential for Loss of Mechanical Movements and FlexMove Carriage with C-Arc Assembly to Fall

05-June-2023

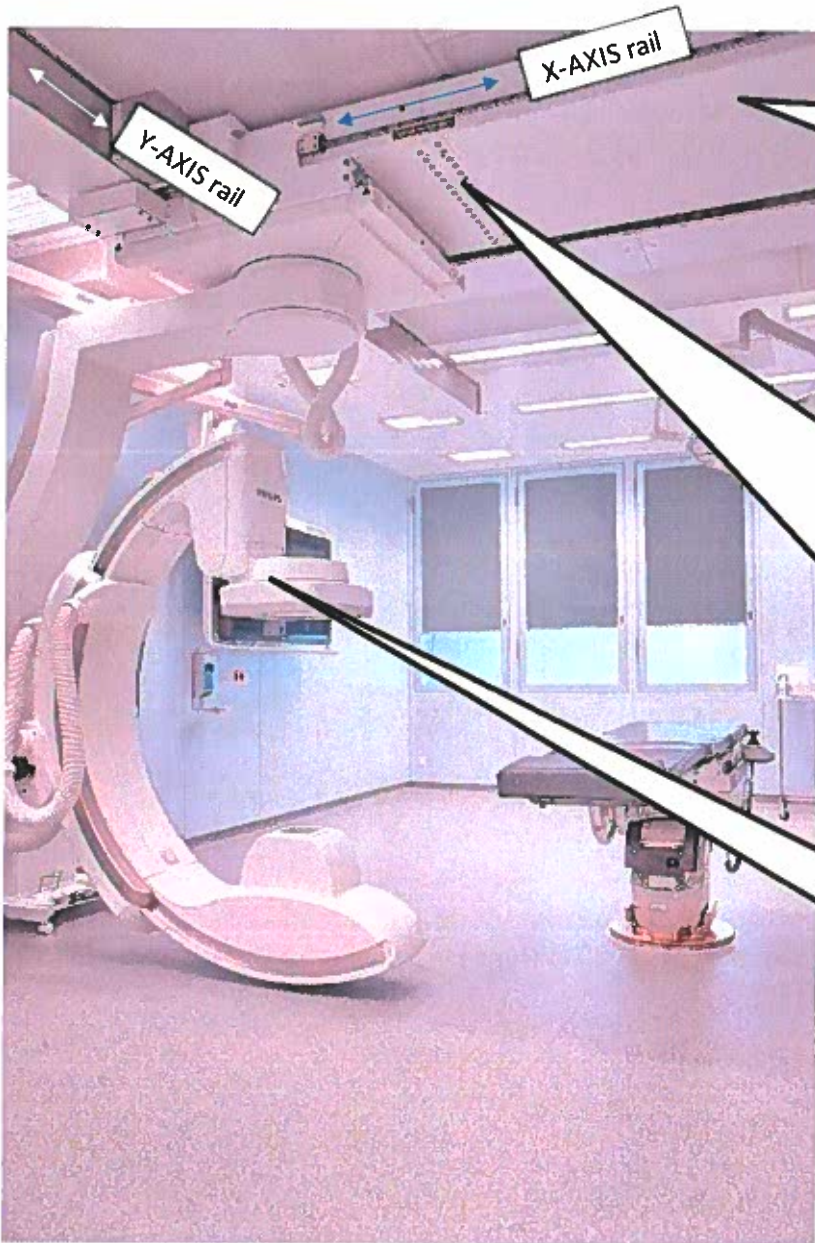
Figure 1

Philips has identified that due to the forces applied during the movement of the C-Arc of the Azurion and Allura systems, the bolts supporting the FlexMove Carriage may become loose and/or break, and cracks may appear in the FlexMove Carriage (see Figures 1, 2 and 3).

- Transversal movements of the C-Arc stop due to false collision detections because of additional friction.
- Manual movement of the FlexMove Carriage not possible due to added friction.
- Abnormal noise during transversal movement of the C-Arc.
- Unstable C-Arc suspension.
- Fall of the C-Arc Assembly (1,500 kg), if all bolts in the X-axis would break/get loose.
- Drop of the C-Arc Assembly (up to 10cm if C- Arc is at one side of the rail, up to 5 cm if C-Arc is in the center of the rails, and 1.5 cm if the C-Arc is in the Anterior/Posterior position), if all bolts in the Y-axis would break/get loose.

C-Arc Assembly

Philips will inspect all affected systems to:

- Check if there are cracks in the FlexMove Carriage
- Check if the FlexMove Carriage's bolts are secured properly
- Replace any loose bolts and broken bolts.

If, during the inspection, it is not possible to replace the identified loose or broken bolt(s), or if cracks are identified, Philips will plan for the replacement of the affected bolts and/or FlexMove Carriage.

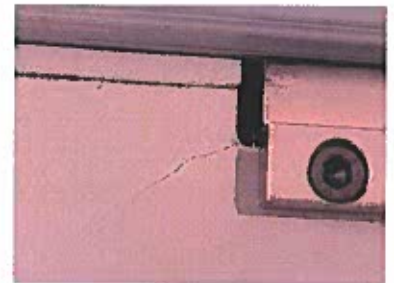
Figure 2

FlexMove Carriage Assembly

Cracks may appear in one or more of the corners around the tie strap as seen in the photo below (4 places on each side)

- Keep this Urgent Field Safety Notice with the documentation of the system until Philips corrects your system. Ensure the letter is in a place likely to be seen/viewed.
- In case of cracks in the FlexMove Carriage (see Figures 2 and 3), please contact Philips so that inspection of your system can be prioritized.
- In case of abnormal noise during transversal movements of the C-Arc, please contact Philips so that inspection of your system can be prioritized.
- Please circulate this Urgent Field Safety Notice to all users so that they are aware of the issue.
- Please complete and return the attached response form (on page 9) to Philips promptly and no later than 30 days from receipt. Completing this form confirms receipt of the Urgent Field Safety Notice and understanding of the issue and required actions to be taken.

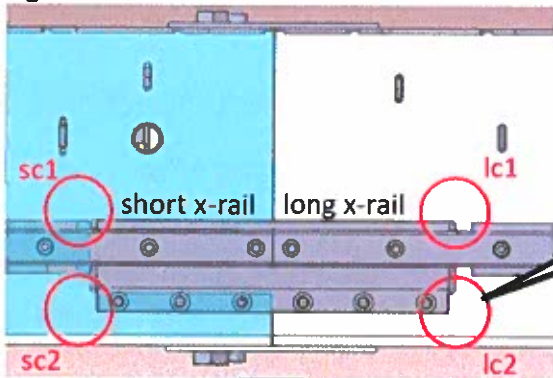
Figure 3

Indication of 4 locations on (each side of) the X-axis rail of the FlexMove Carriage where cracks may occur.
