Reference: 2023-005M

URGENT - FIELD SAFETY NOTICE

RE: TRACHEAL INTUBATION FIBERSCOPE, TRACHEAL INTUBATION VIDEOSCOPE

Models: Olympus LF-TP, LF-DP, LF-GP, LF-V and LF-P

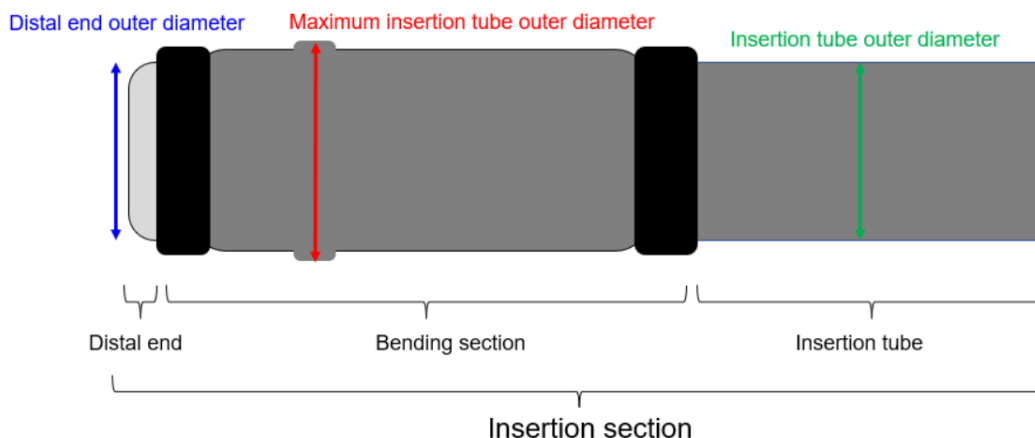
Olympus has received three complaints, including one that was associated with an injury, that upon trying to use an Olympus pulmonary endoscope model with an endotracheal tube, the tip became lodged (entrapped) inside the endotracheal tube connector.

As a result of the complaint investigation, it was determined that the scope (bending section) was too large for the endotracheal tube connector.

To mitigate the selection of incompatible endotracheal tubes, please refer to the Addendum which provides information on the maximum insertion tube outer diameter. Refer to the image below to identify the different sections of the insertion section:

- Before inserting the tracheal intubation scope with an endotracheal tube into the patient, slide the tube along the entire length of the tracheal intubation scope insertion section to confirm that the insertion section of the tracheal intubation scope can be inserted smoothly into the endotracheal tube. If it cannot be inserted smoothly, the covering material of the bending section of the tracheal intubation scope or the external surface of the insertion section may be damaged. When using a lubricant, make the above confirmation before applying the lubricant.

In the event the endotracheal tube cannot slide smoothly over the insertion section of the tracheal intubation scope, please select another size tube, or inspect your scope for damage.
