**Customer Safety Advisory Notice MR072/23/S**

**Customer Information about possible artifacts from over-ear headphones during head examinations**

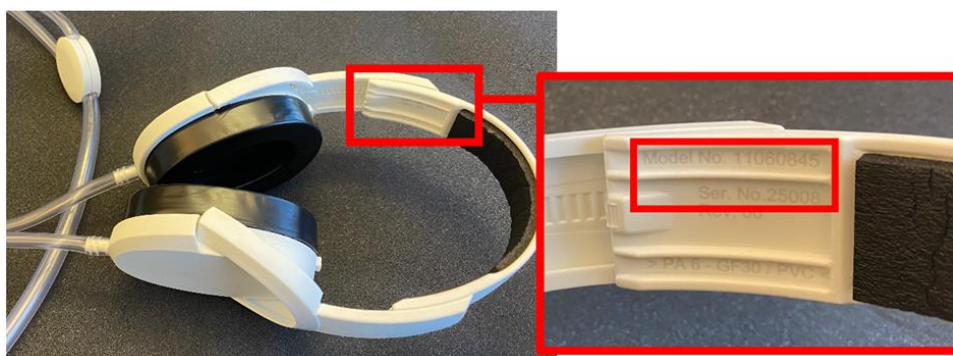
Figure 1: Location of model number and serial number on over-ear headphones

- Check the model number and serial number of your over-ear headphones. See *Figure 1* for their location on the over-ear headphones. If the model number is not identical or the serial number is outside the stated range (7981 – 32200), they are not affected.

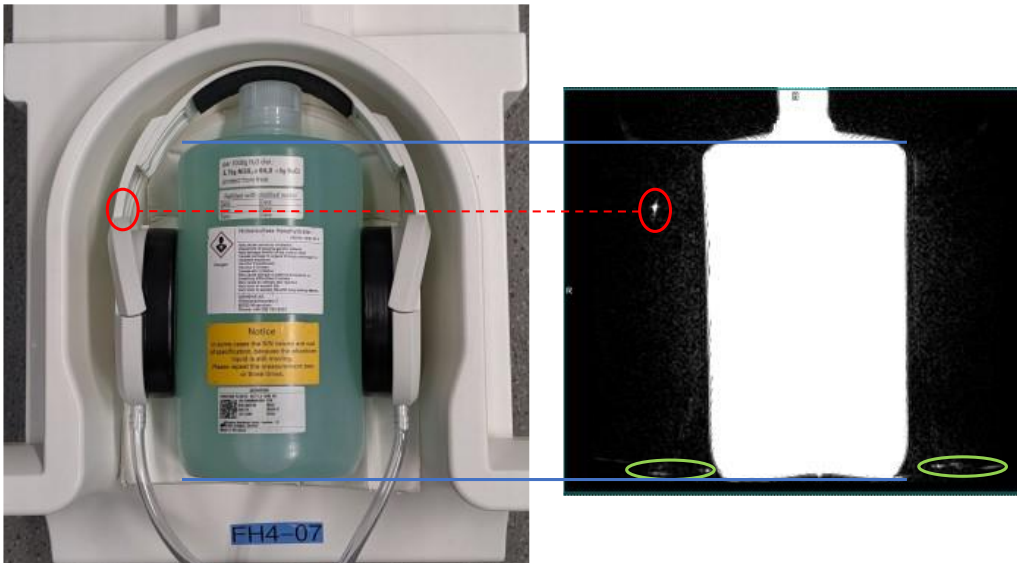
Figure 2

In some cases, when lubricating grease is present within the headband of the over-ear headphones, it may cause visible, dot- or line-shaped, fat-isointense artifacts during **head examinations only**. These potential artifacts depend on the position of the headband, the amount of lubricating grease, as well as the sequence parameters used. This issue does not impact scans of other body regions.

Siemens Healthineers became aware of this issue during post market surveillance. The root cause has been identified as a manufacturing processing error.

Left side: correct setup of phantom bottle and headphones in head coil

Right side: Example of signal from lubricating grease can be seen outside the phantom, marked with a red circle. The artifacts must be on the same height as the potential affected headbands of the headphone.

*Please note: MR imaging often shows artifacts with phantom bottles in this extreme windowing e.g., at the top and/or bottom of the phantom. These artifacts are marked with green circles in the above example and can be ignored.*

- If **artifacts are visible** during the described phantom measurements, your over-ear headphones are affected and must not be used for head examinations. In this case, please use the built-in loudspeaker in the scanner for patient communication or, if available, in-ear headphones which are also not affected by the described issue.

Siemens Healthineers will correct the issue by exchanging the headband of the affected over-ear headphones at customer sites with the field update MR073/23/S. This replacement program will start in October 2023. With the exchange of the headband the root cause is eliminated.
