August 28, 2023

URGENT FIELD SAFETY NOTICE
MEDICAL DEVICE CORRECTION
FSCA 2249723-06/02/2023-009-C & FSCA 2249723-06/02/2023-012-C
Datascope Cardiosave Hybrid and Rescue Intra-Aortic Balloon Pumps (IABP)

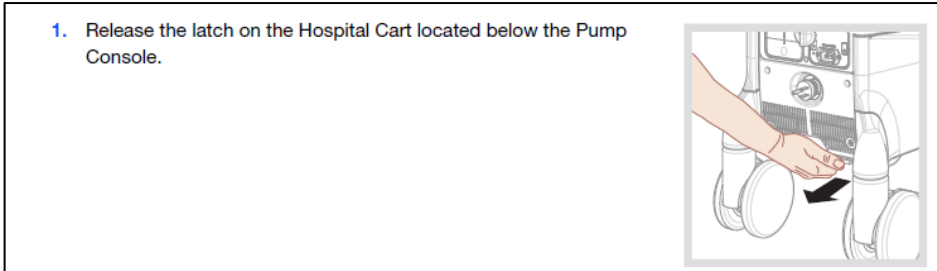
- 1) The Cardiosave Hospital Cart's release latch has been released and the IABP console is not properly installed in the cart.

If the AC Plug Icon is not present and/or the Rescue Icon is present, release the latch on the Hospital Cart located below the Pump Console, then grab the handle and slowly slide out the console approximately one quarter of the way.

Grab the handle and slowly slide the Pump Console into the Hospital Cart until it locks into place. You will hear an audible click noise and three audio tones of increasing volume will sound once the console is locked into the Hospital Cart.

To ensure the Pump Console was successfully installed into the Hospital Cart, plug the Hospital Cart power cord into a compatible grounded AC receptacle, and confirm AC operation by checking the battery icon to confirm the pump is using AC power.

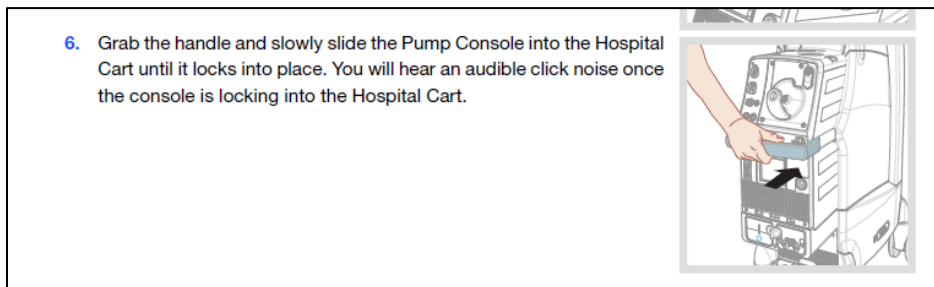
- 2) The IABP console is inserted into the hospital cart, but is not fully latched into the cart

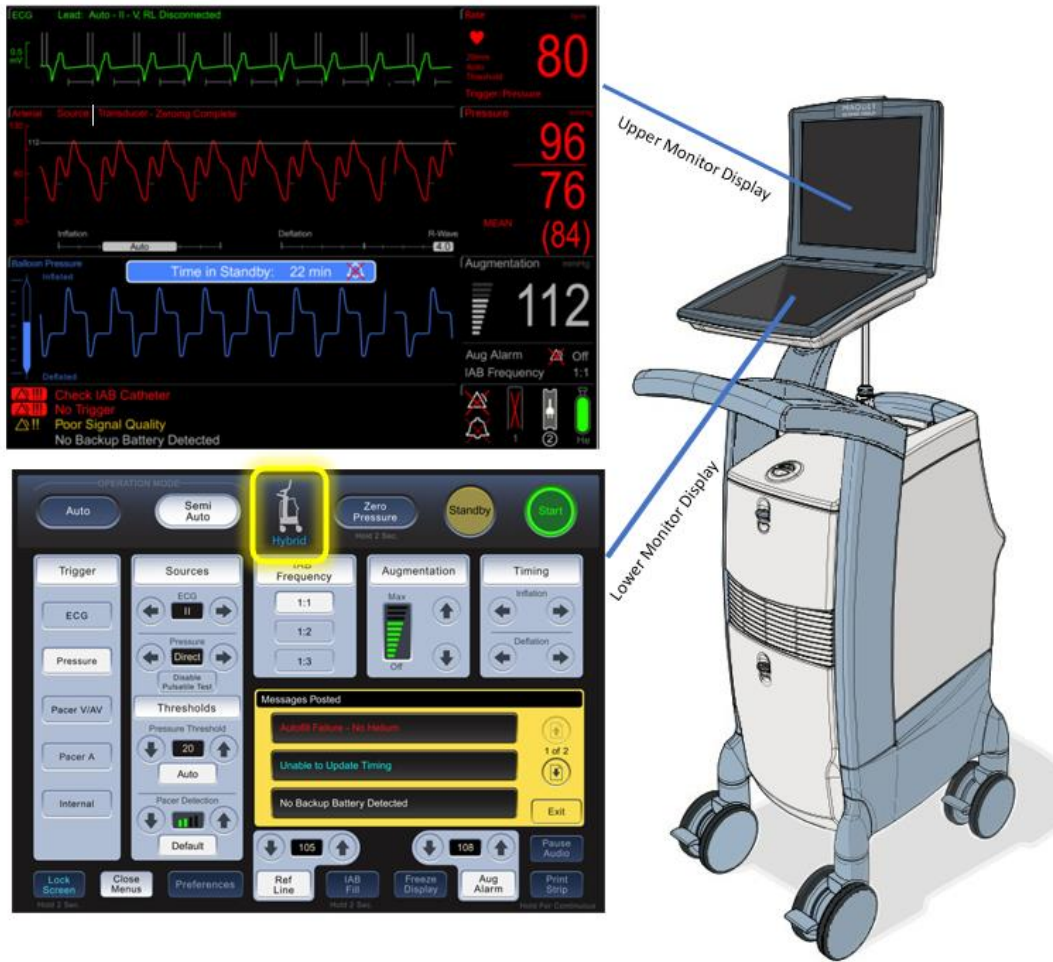
Cardiosave Upper and Lower Display

In both cases, information is provided to the user that the system is not in Hybrid mode via the Rescue Mode Icon on the bottom Cardiosave screen (top center of the screen). In addition, the “battery in use” message will be displayed in the informational message area even if the AC power cord is plugged in.

Additionally, in both scenarios, the Cardiosave will not receive AC power and if the device is in operation, it will continue to operate on battery. When the Cardiosave is not receiving AC power, the batteries are unable to charge.
