URGENT Field Safety Notice

Azurion 7 M20 FlexArm system with Maquet Magnus Table
 Unavailable Motorized Table and/or FlexArm Movement Potentially Resulting in Delay or Termination
 of Procedure.

08-DEC-2023

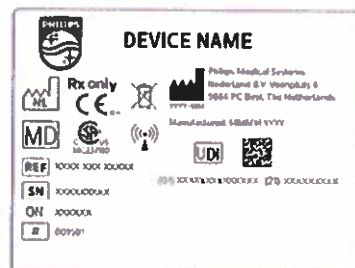
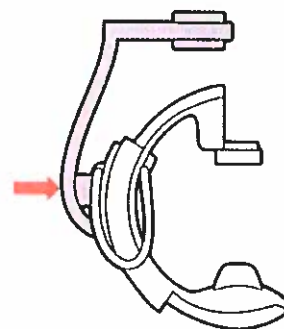
The Device Name, Product Code, Serial Number, and UDI can be found on the System Identification Label located on the FlexArm stand:
