URGENT Field Safety Notice
ProxiDiagnost N90 1.1 and ProxiDiagnost Upgrade

Software Defects causing imaging issues during Radiography and Fluoroscopy examination

05-December-2023

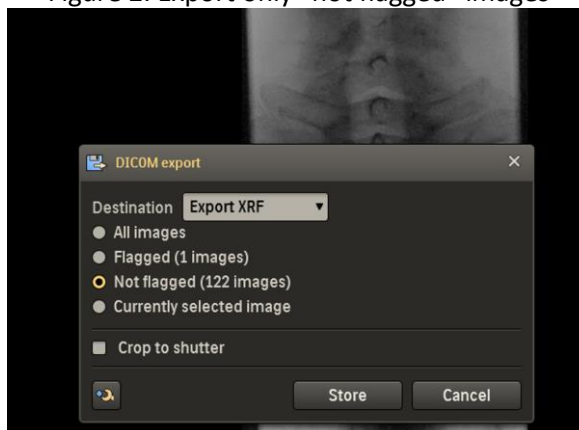
Figure 2. Export only “not flagged” images

Issue 1: Mixed Images: Philips has identified that the Radio Fluoroscopy (RF) viewer may also display a previous patient's radiography (RAD) images when starting the next patient scan while the previous patient image export is still processing. If the issue occurs, there is a potential for incorrect patient data to be displayed in the image.

Issue 1: Mixed Images: There is a potential for misdiagnosis or wrong treatment if images of the same anatomical region are mixed up with a different patient.

- To avoid previous patient data from being represented as current patient data, ensure all images have been exported from the previous RAD exam before starting a new examination.
- Correct images will be square shape and wrong images can be recognized by a different patient anatomy and rectangular shape. If you identify a wrong image, flag the incorrect images and only export “not flagged” images for the current examination to PACS (See figure 2 below).
