D001609405;A.2;Released;C&R 2023-PD-MR-007 FSN-Global;-

URGENT Field Safety Notice

MR Systems: Patient support floor plate cage installation issue leading to potential for tipping

12-Mar-2024

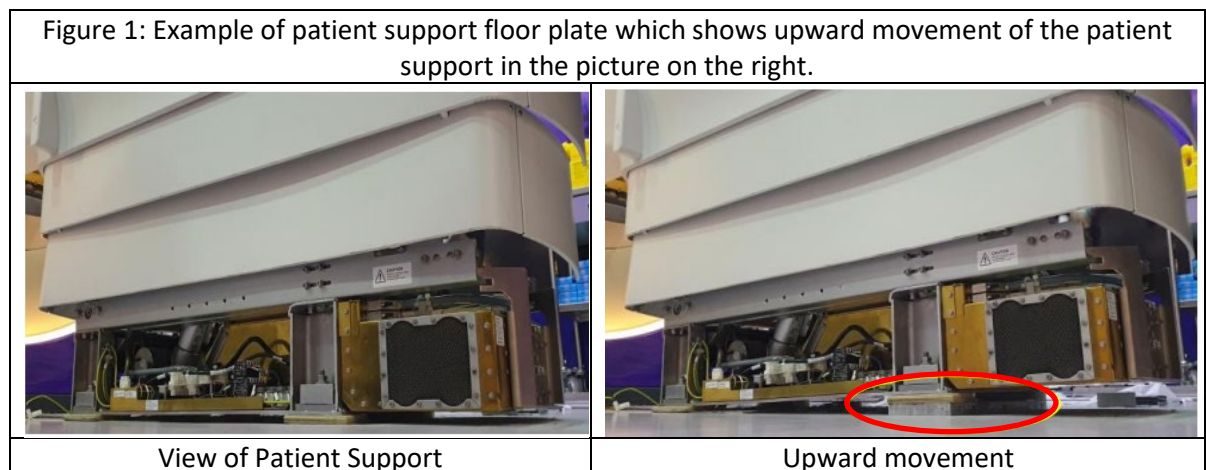
The patient support floor plates for MR systems may not have been anchored to the floor according to Philips requirements causing the patient support to become unstable with the potential for tipping (see Figure 1). This movement can inadvertently lead to harm to the patient and/or operator under certain circumstances.

If the patient support were to become dislodged from the floor, the risk to patients or operators may include physical harm from falling from the table, pinching of extremities or other body parts between the patient support and system or floor, and/or delayed diagnosis.

- D. If the patient support has any unexpected movement and / or becomes unstable (dislodged movement between the system and the floor), immediately stop use and contact your Philips service representative for interim support.
- E. Circulate this notice to all users of this device so that they are aware of the potential issue.
- F. Please display attached 'Advisory' with your system(s); ensure the notice is in a place likely to be seen/viewed by operators.
- G. Please complete and return the attached acknowledgment form to Philips MR promptly upon receipt and no later than 30 days from receipt via email to: pd.cnr@philips.com.

A Philips representative will contact you to schedule time for an FSE to visit your site to perform an inspection regarding the patient support stability. (Reference FCO 78100570).

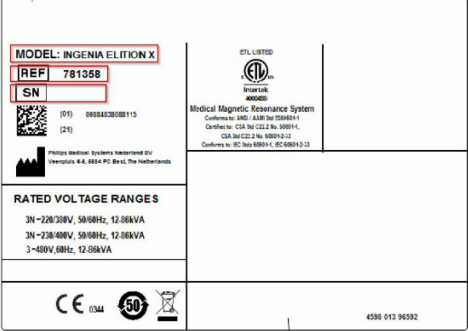
Potentially impacted systems can be identified by the Model and REF number (REF). The Model name and REF can be found on the system label, as indicated by the red boxes in Figure 2.

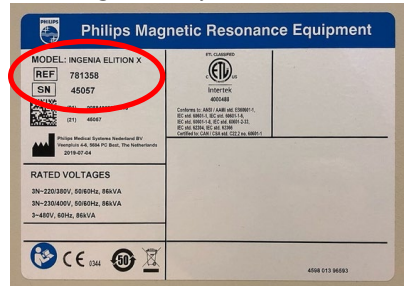
Figure 4: system label

1. Enter the Technical Room
2. Locate the system label (see Figure 3) which can be found on the cabinet door
3. Locate the model and reference number on the system label (see Figure 4)
