URGENT Field Safety Notice

Philips **Interventional Hemodynamic Application** R1.2.X, R1.3.0 and R1.3.1
Potential incorrect functional measurement

30-APR-2024

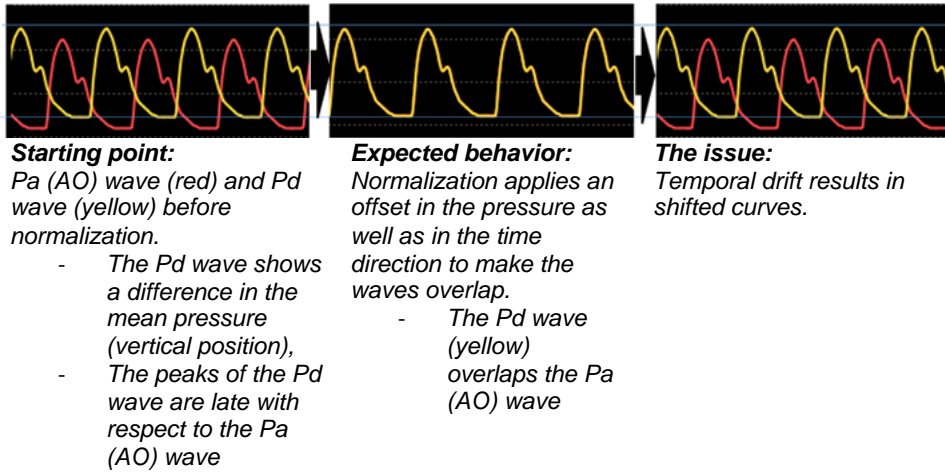
Philips has become aware that this synchronization may not be correct, which causes the wave data from one device to be delayed with respect to the wave data from the other device. This time shift can occur in two different forms, being:

- A delay of the Pd wave with respect to the Pa wave that is increasing over time ('drift'). The drift decreases in time towards zero eventually leading to a constant shift between the Pa wave and Pd wave (see Figure 1 below).

Figure 1 – Pa (AO) wave (red) and Pd wave (yellow) normalization issue

A delay of the Pd wave with respect to the Pa wave can result in incorrect functional measurements, which may lead to misdiagnosis (under or over treatment due to the drift going unnoticed).

- Step 4: Allow the wire to “auto-zero” again (see Step 1) and continue with the iFR or FFR measurement.
- In case the steps described above are not executed and/or the described issue is observed, perform the normalization procedure in accordance with Section 6.9 of the Instruction for Use

Philips will install a software update to correct this issue. A Philips representative will contact you to schedule an onsite visit to perform the upgrade (reference FCO72200542).

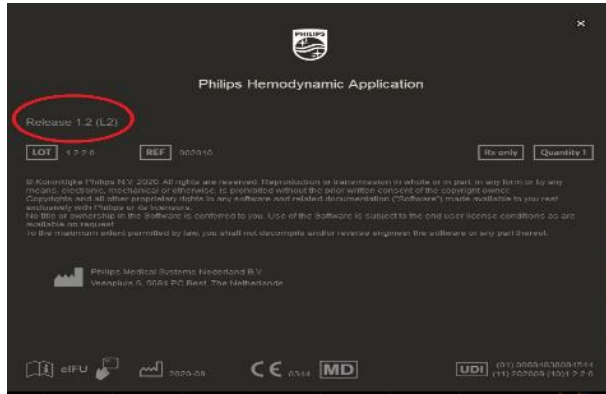
The software version of Philips Hemodynamic Application can be identified in the “About” box of the Philips Hemodynamic Application. The “About” box is shown when the application is opened, and the release version is displayed at the upper left section of the screen as shown in Figure 2 below.

Figure 2 – “About” box indicating release version

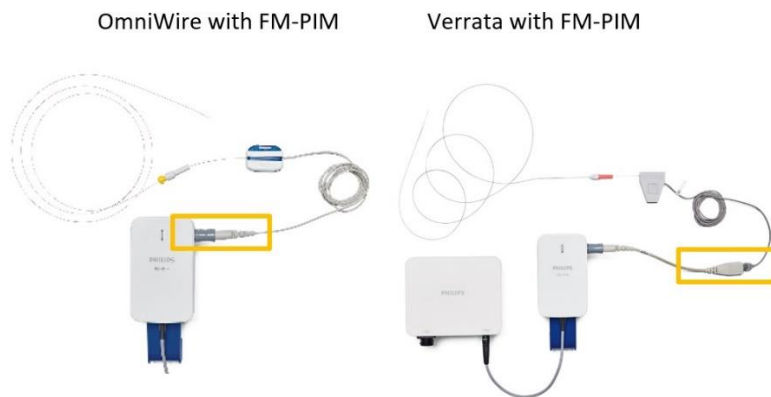
Figure 3 – Connection points of two types of cables (OmniWire and Verrata) to the FM-PIM to be used

- Step 1: Connect the cable of the OmniWire or Verrata wire to the FM-PIM. The Philips Interventional Hemodynamic System will start “auto-zeroing” the pressure wire and the PHA display in the exam room during this process will automatically show the message “Auto-zeroing the FM-PIM pressure wire”.

- Step 2: Disconnect the cable from the FM-PIM and wait for the Philips Interventional Hemodynamic System to show the message “Connect the plug of the FM-PIM” on the display in the exam room.

- Step 3: Reconnect the cable again with the FM-PIM. Use the cable connector indicated with the yellow boxes in the Figure 3 below.
