URGENT Field Safety Notice

Allura Xper, Allura Centron, and Azurion Systems: PC Issues
 Potential Loss of System Functionality which May Result in Delay or Termination of Procedure

28-December-2023

Reference: 2023-IGT-BST-027: Allura Xper, Allura Centron, and Azurion Systems: PC Issues
Potential Loss of System Functionality which May Result in Delay or Termination of Procedure

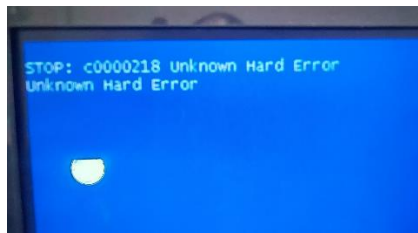
1. Switch to a different viewport on the FlexVision monitor. Upon switching viewports on the FlexVision monitor, FlexVision shows no image, a distorted image, a frozen image, or you are unable to switch between viewports (i.e., warning/error message displays “*Switching not possible. Call Service*”); or
2. System displays a Windows “blue screen” (see example below), regardless of what specific message is provided on the screen.

Example of Windows “blue screen”

Do not use the system and contact your local Philips representative immediately.
