**URGENT Field Safety Notice**

**MR systems with 60cm wide bore**

Quadrature Body Coil (QBC) seal adhesive failure may result in exposure of sharp edges

28-December-2023

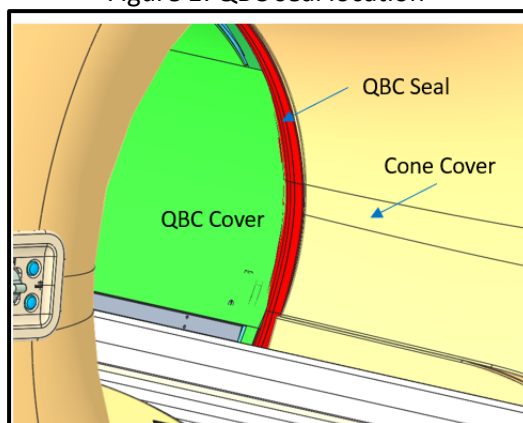
Figure 1. QBC seal location

The Quadrature Body Coil (QBC) seal adhesive may fail creating sharp edges that may come in contact with patients. The QBC seal may become loose as the patient table travels in a horizontal motion in and out of the system bore. The QBC seal (Figure 1) is a rubber seal that is glued between the cone cover and QBC cover and functions to prevent sharp edges of the QBC cover from contacting patients during an examination.

Philips has received three (3) reports of adverse events associated with this issue, one patient received a cut on the hand, one patient's hair became entangled resulting in a scalp injury, and one patient received lacerations to the upper left arm.

If the QBC seal becomes loose during the scanning process, the risk to the patient may include one or more of the following: skin abrasions, bruises, lacerations, hair loss/entanglement, and tissue injury.

- As part of the preparation before a patient scan:
  1. Inspect the QBC seal for separation between the cone cover and QBC cover.
  2. If QBC seal is found detached or loose, **Stop-use immediately**.
  3. Contact your local Philips service representative.
- If QBC seal becomes loose during a patient scan:
  1. **Immediately stop scanning** and carefully remove patient from the system.
  2. Contact your local Philips service representative.
- Circulate this URGENT Field Safety Notice to all users of this device so that they are aware of the issue.
- Please retain this letter with your system(s) until a solution is installed on your system; ensure the letter is in a place likely to be seen/viewed.

Philips will contact you to schedule a time for a Field Service Engineer (FSE) to visit your site and replace your system's QBC Seal (reference FCO78100573). Philips plans to start implementing corrections in Q3 2024.
