**Product Advisory (No disposition of product)**  
**APM-26-06129**

ForeSight™ Oximeter Cable Labels Switched  
Affected Model Number: HEMFSM10

13 Aug 2026

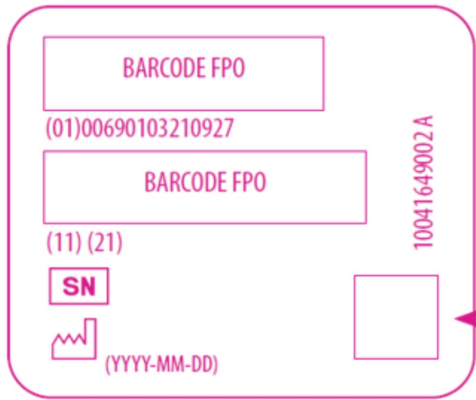
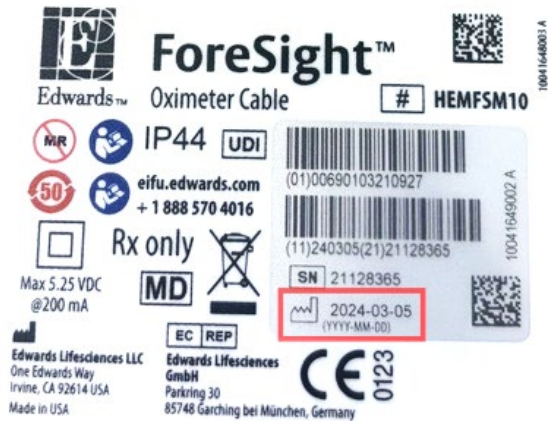
Based on customer feedback, Edwards Lifesciences has identified that during manufacturing, the laterality identification labels may be missing or inaccurately placed on the device. There is potential that the labels on the green cables may have been switched, with the channel 1 cable labeled as channel 2, and the channel 2 cable labeled as channel 1. This will lead to a mismatch as to the left and right values displayed on the monitor and what the labels indicate on the cables. This issue may affect certain devices manufactured between June 01, 2021, and June 30, 2026 (see below to identify the location of manufacturing date).

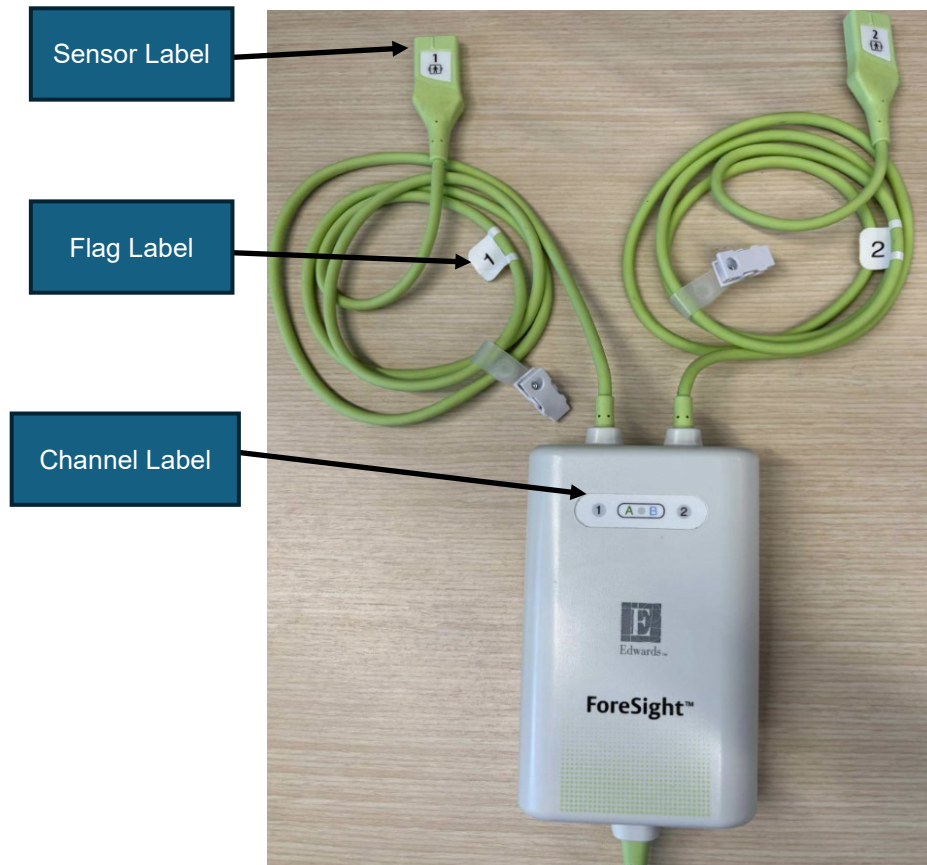
1. Verify for the presence of the flag, sensor, and channel labels on the device.
2. Verify that the flag and sensor labels correspond to the correct channel label (A1 on left / B2 on right) on the housing (See picture below for correct label placement).

3. If either of the labels are missing, or the flag label and/or the sensor label do not match the channel label on the housing, contact : [APMTechServiceSEA@bd.com](mailto:APMTechServiceSEA@bd.com) Technical Support for further assistance.
4. If the flag and sensor labels correctly correspond to the channel labels, as seen in the picture below, there is no further action required.
