## **URGENT MEDICAL DEVICE CORRECTION**

### **AIC Purge Pressure Sensor Assembly Failures**

August 13, 2026

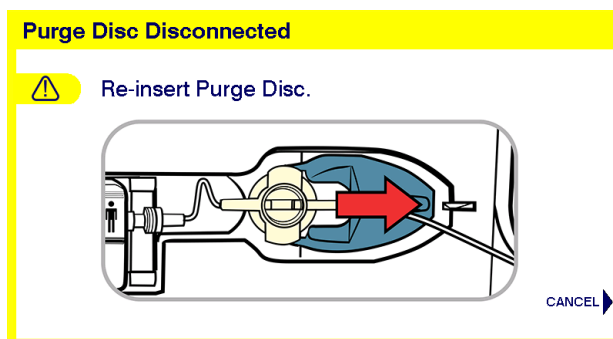
Abiomed has identified an increase in complaints due to purge cassette recognition issues resulting from failures of the purge flag component within the purge pressure sensor assembly. The purge flag engages with the purge disc and allows the AIC to recognize that the purge disc is inserted properly. Abiomed is addressing these failures by replacing the purge flag and purge retainer components within the purge

If a purge flag component failure were to occur during set up of clinical procedure, the user would see a "Purge Disc Disconnected" alarm on the AIC. As per the Instructions for Use (IFU), first reinsert the purge disc to address the alarm. If that action does not clear the alarm, switch to a backup Automated Impella Controller. Refer to below for an example of the alarm:

- In the event of these purge flag component failures and associated alarms, as per IFU, first reinsert purge disc to address the alarm. If that action does not clear the alarm, switch to a backup Automated Impella Controller.
