## Quality Notification

### MY-QN-RDS-MolecularLab-2026-105

RDS / Molecular Diagnostics

## Deformed cobas omni Processing Plate 24 on cobas® 5800

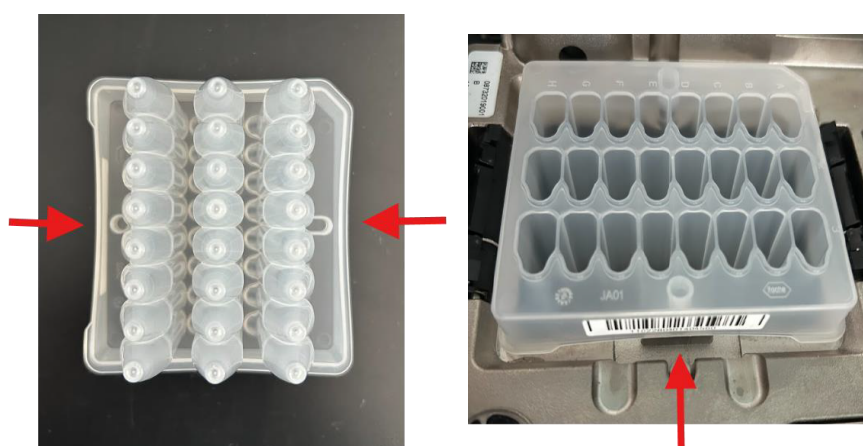
Customer complaints were escalated reporting deformed cobas omni Processing Plate 24 consumables used in conjunction with the cobas® 5800 System. The affected plates show inward curved margins, which prevent correct placement on the separation station and heating station of the cobas® 5800 instruments (see Figure 1).

Figure 1: Right: Examples of a defective cobas omni Processing Plate 24. Left: Image showing defective plates incorrectly positioned within the processing station.

Due to this structural irregularity, these consumables fail to remain level in their designated position. The cobas® 5800 system lacks the capability to detect such structural deformation in the plates during the loading.

Consequently, the processing will start and proceed until the consumable is positioned on the separation station. At that point of the process, the misalignment leads to run abort and/or invalid test results. Specifically, the following flags and errors have been observed:

- **Invalid with P07P flags** with specific pattern (multiple samples invalid in the same processing plate, all placed along the same rows or columns).
- **Y16-flags** (mechanical error of the process transfer head) denoting hardware-related problems at the processing transfer head.
- **Processing transfer head force control error** (*ErrorCode: 0x0303 / CDI: 0x00102100 / HD24: The start value is under the defined lower limit. Sensor may be defective*).

Although the investigation is still on-going, the cause of the deformation is related to unexpected temperature fluctuation in a specific step of the processing plates manufacturing.

Customers are requested to discontinue the usage of the cobas omni Processing Plates 24 lots listed in Table 1 and discard immediately.
