Field Safety Notice

Height Adjustable (HA) FlexTrak Trolley
 Potential falling hazard resulting from HA FlexTrak Trolley oil leakage

May 03, 2024

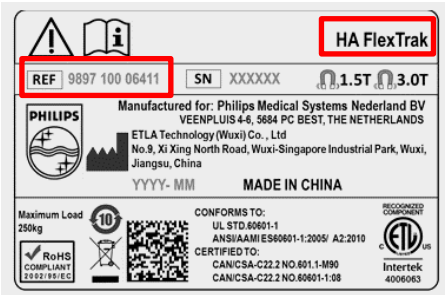
Impacted products can be identified by the product name and product number (REF) as shown in Figure 1.

Example Product Label	Product Name	Product Number (REF)

HA FlexTrak	989710006411
		989710006412

<p>HA FlexTrak II</p>	<p>989710008732</p>
--	-----------------------	---------------------

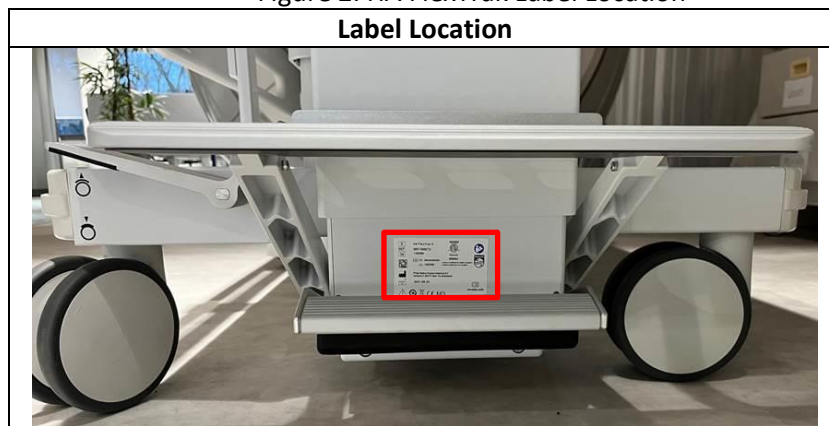
Figure 2. HA FlexTrak Label Location

The HA FlexTrak identification label is positioned on the handgrip side of the trolley below the pump pedal, as shown in Figure 2.
