August 28, 2023

URGENT FIELD SAFETY NOTICE
MEDICAL DEVICE CORRECTION
FSCA 2249723-06/02/2023-009-C & FSCA 2249723-06/02/2023-012-C
Datascope Cardiosave Hybrid and Rescue Intra-Aortic Balloon Pumps (IABP)

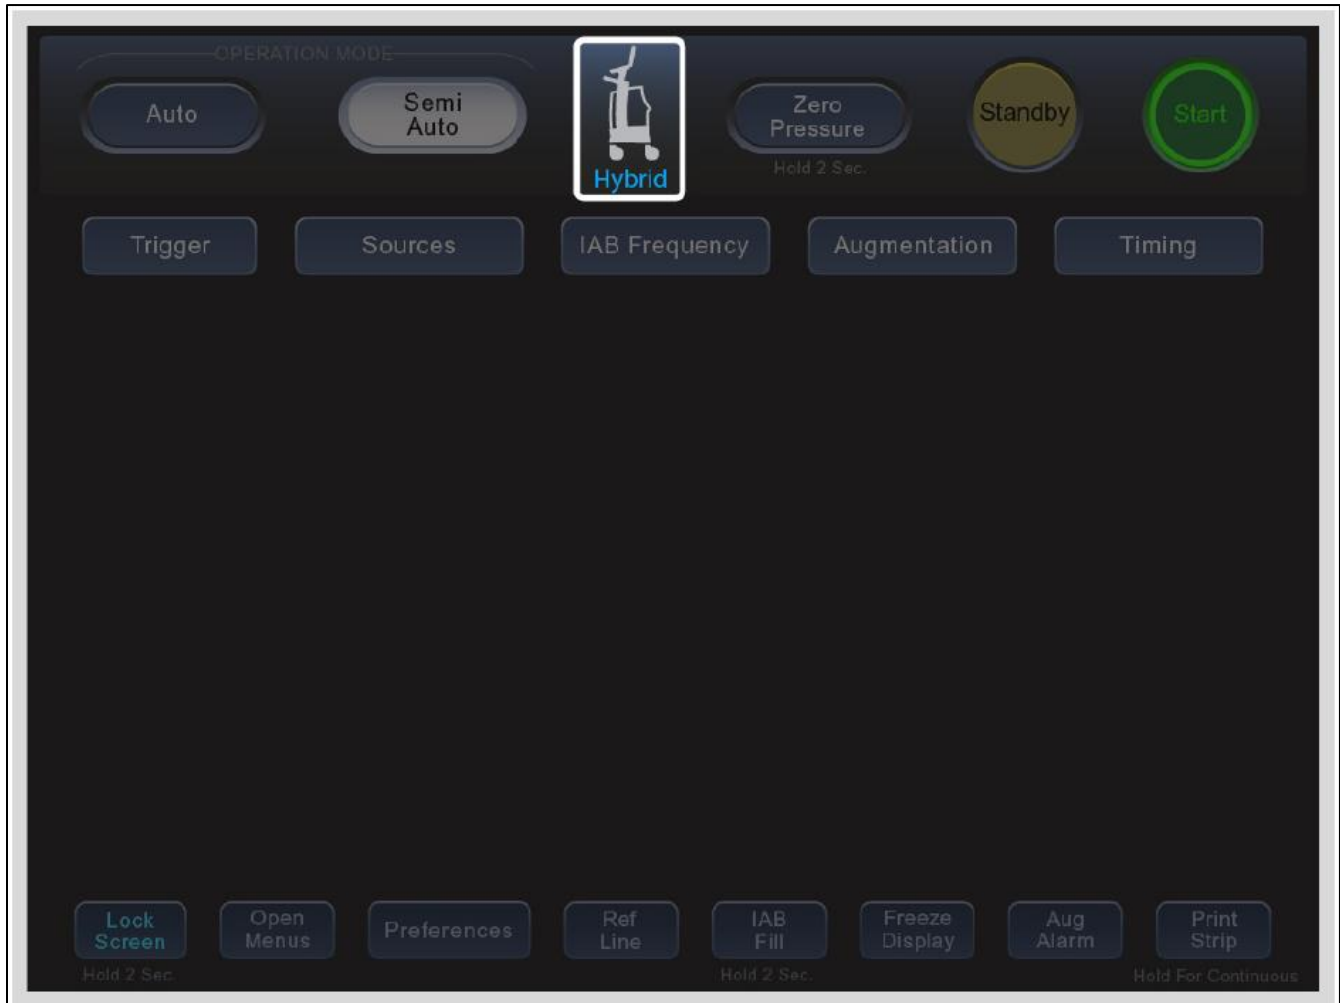
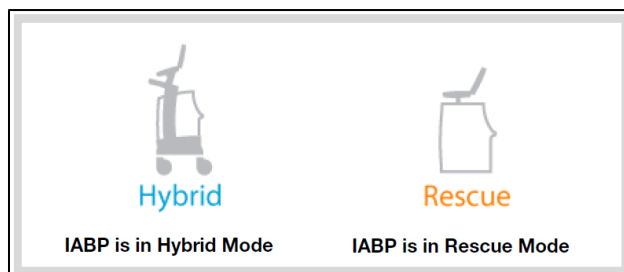
The IABP Configuration Icon shows the current mode of configuration for the IABP, Hybrid (in the hospital cart) Mode or Rescue (transport) Mode. The icon is located at the top center of the IABP display screen.
