URGENT Field Safety Notice

MR systems terminal connections in the general Mains Distribution Unit (g-MDU) may produce a Thermal Event

19-April-2024

Reference: Terminal connections in the general Mains Distribution Unit (g-MDU) may produce heat triggering the smoke/fire alarm (reference FCO78100582)

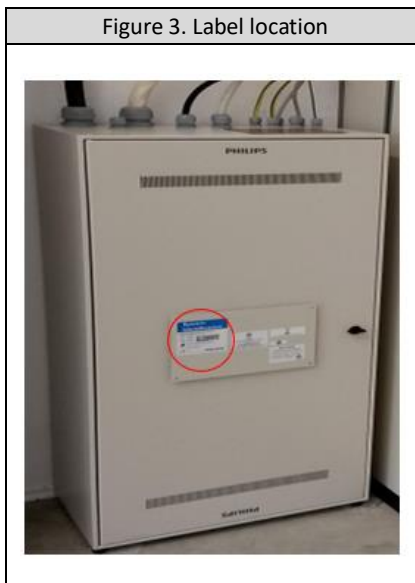
Figure 3. Label location

- Enter the Technical Room
- Locate the Mains Distribution Unit (gMDU)
- The label is located on the front door of the gMDU, (see Figure 2)
