**To the Customers of the  
Dräger VentStar Resus Neo / VentStar Resuscitaire**

### **Important safety notice!**

#### **Possible leaks due to cracks**

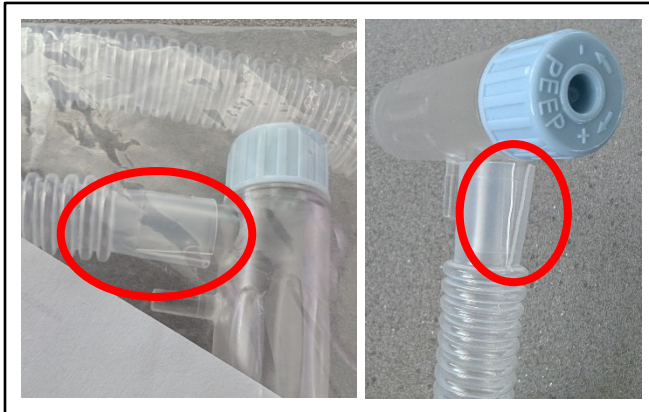
As part of our global market monitoring, we have become aware of cases in which obvious cracks in the hose of our VentStar Resus Neo and VentStar Resuscitaire were detected by the users prior to use. In no case we were informed of any negative effects on the health of the affected patients. However, this cannot be completely ruled out if such crack remains undetected.

**In case a cracked hose is used, the hose could fall off or leakage will occur. Depending on the leak, ventilation will be restricted and therapy could be delayed potentially resulting in desaturation, hypoxia or patient death.**

Our analyses revealed that affected hoses developed cracks shortly after the manufacturing and assembly process. Stress tests on “flawless” hoses have shown that they can safely be used as always.

**Fig. 1. Cracked hose with PEEP valve**

#### **1. Carefully inspect the hoses for damages prior to use according to the product's Instructions for Use (IfU).**

- 2. Discard products that show cracks (Fig. 1) or have a detached hose (Fig. 2). You do not need to return them to us.**

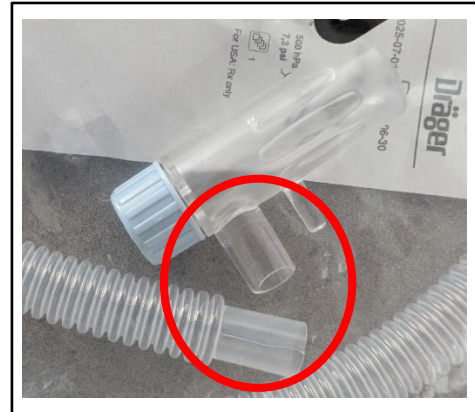
**Fig. 2: Detached hose/ PEEP valve**
